INDOOR AIR QUALITY ASSESSMENT

**Horace Mann School
Oak Street
Franklin, Massachusetts**

Prepared by:
Massachusetts Department of Public Health
Bureau of Environmental Health Assessment
Emergency Response/Indoor Air Quality Program
June 2003

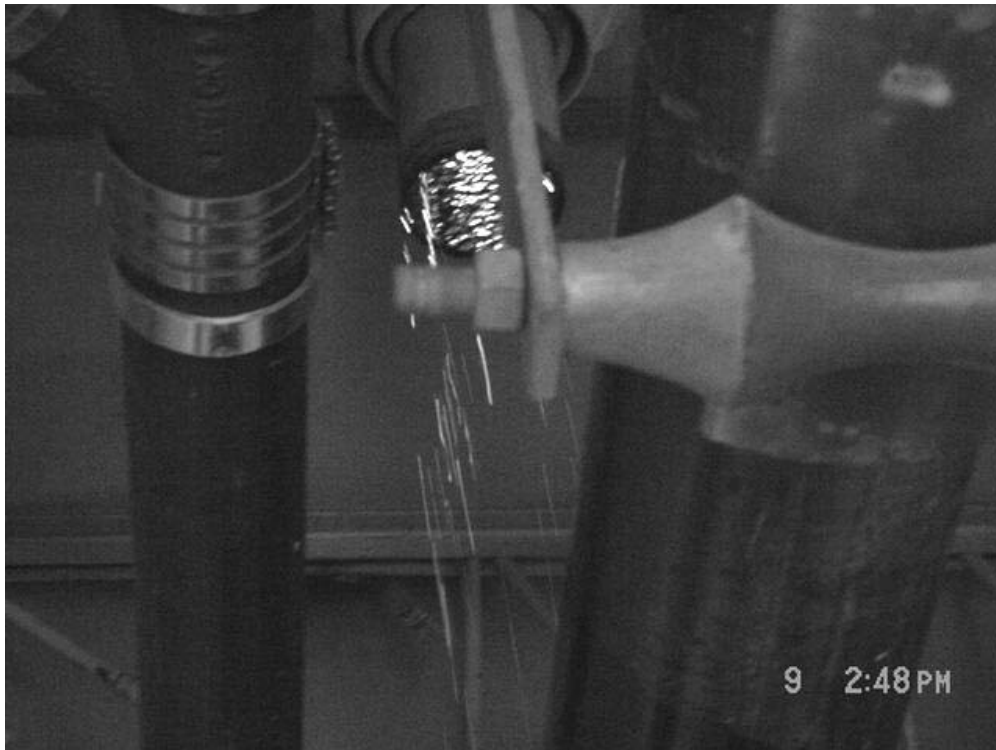
Picture 1

- Active leaks were observed in a number of areas on the top floor of the new addition. Water was noted pouring into the interior of the building through ducts installed in the roof decking (see Picture 1).
- During the assessment, accumulated moisture was noted on ceilings, walls and the cement floor (see Pictures 2-4).
- Blown-on ceiling insulation on floor/roof decking was found to be wet (see Picture 5).
- Water damage was noted on the floor/ceiling of a wing undergoing renovation. A cardboard-like material with a mesh underlay was used as forms for the poured concrete

Water Pouring into the Interior of the Building through Ducts Installed in the Roof Decking

1. Implement previous recommendations made by Covino.
2. Establish the integrity of the building envelop by:
 - 2.1. installing the new roof and
 - 2.2. sealing the exterior wall system to prevent further damage to interior walls.
3. Remediate mold contaminated building materials in a manner consistent with *Mold Remediation in Schools and Commercial Buildings* published by the US Environmental Protection Agency (US EPA) (US EPA, 2001). Copies of this document can be downloaded from the US EPA website at: http://www.epa.gov/iaq/molds/mold_remediation.html.

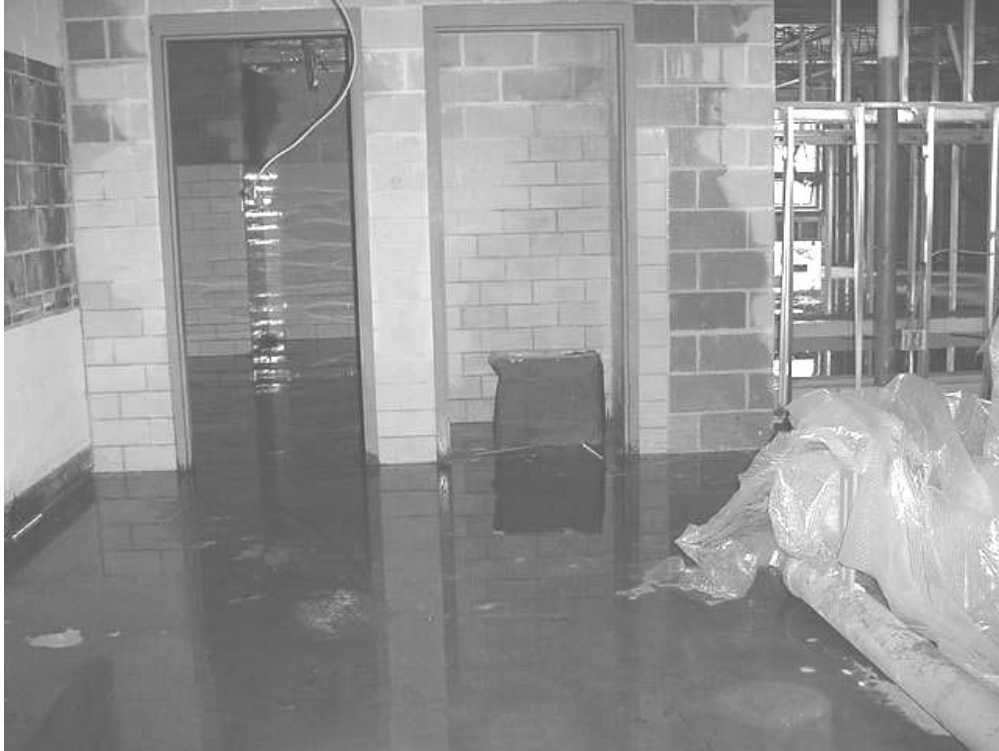
Picture 2

2-4 Inches of Standing Water on Floor Due To Roof Leaks

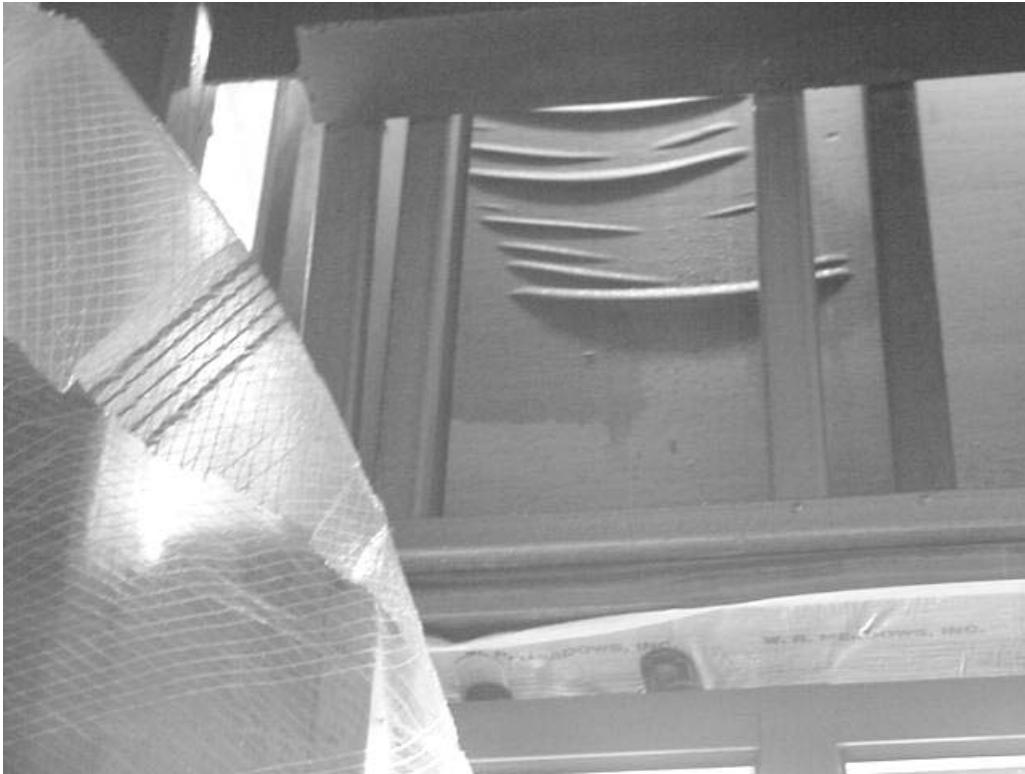
Picture 3

Sagging Paper Backing Of GW Saturated with Moisture

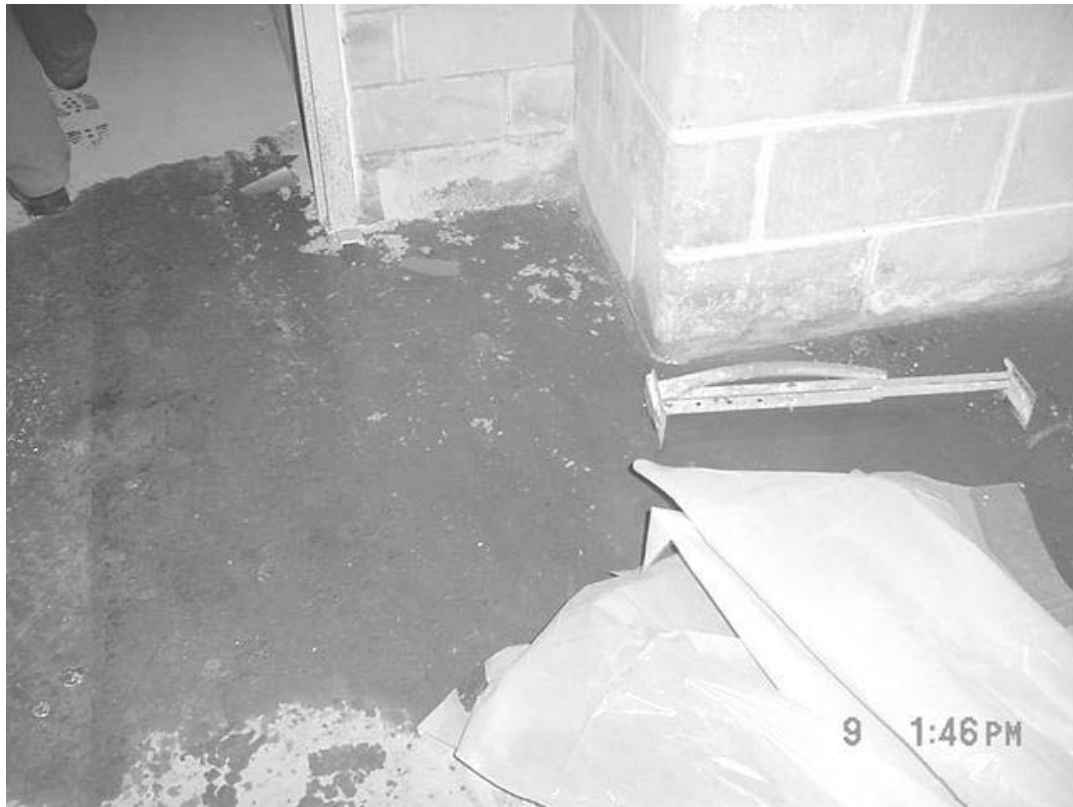
Picture 4

Standing Water on Cement Floor

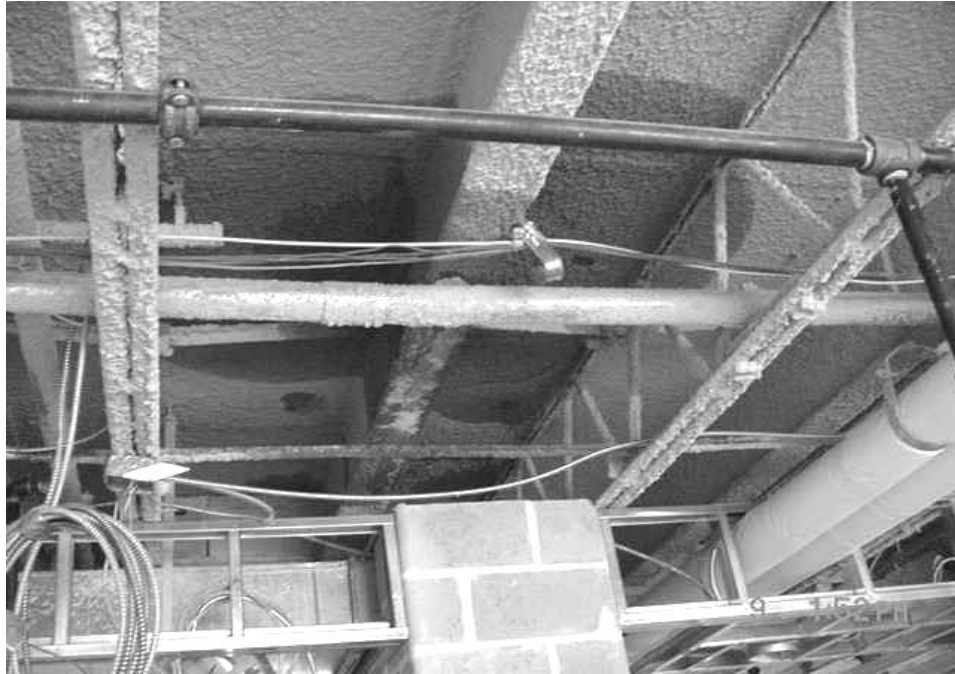
Picture 5

Blown-On Ceiling Insulation Was Found To Be Wet

- 5.1. GW adhered to the Styrofoam-like material;
 - 5.2. insulated ductwork;
 - 5.3. gymnasium floor;
 - 5.4. wall plaster in the auditorium;
 - 5.5. spray-on insulation on roof/floor decking; and

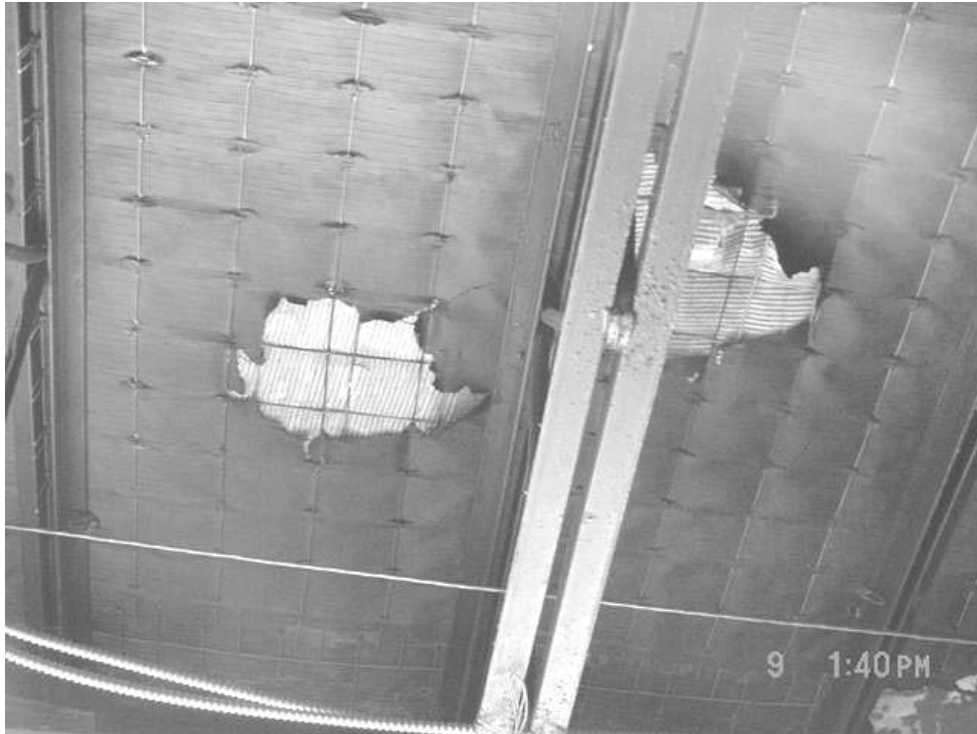
Picture 6

slabs that make up the floor (see Pictures 6 and 7). Water was seen dripping through this mesh, presumably from the moistened cardboard material underlying the concrete slab.

Floors Appeared to Have Been Formed Using a Cardboard-like Material Held By Cloth Mesh

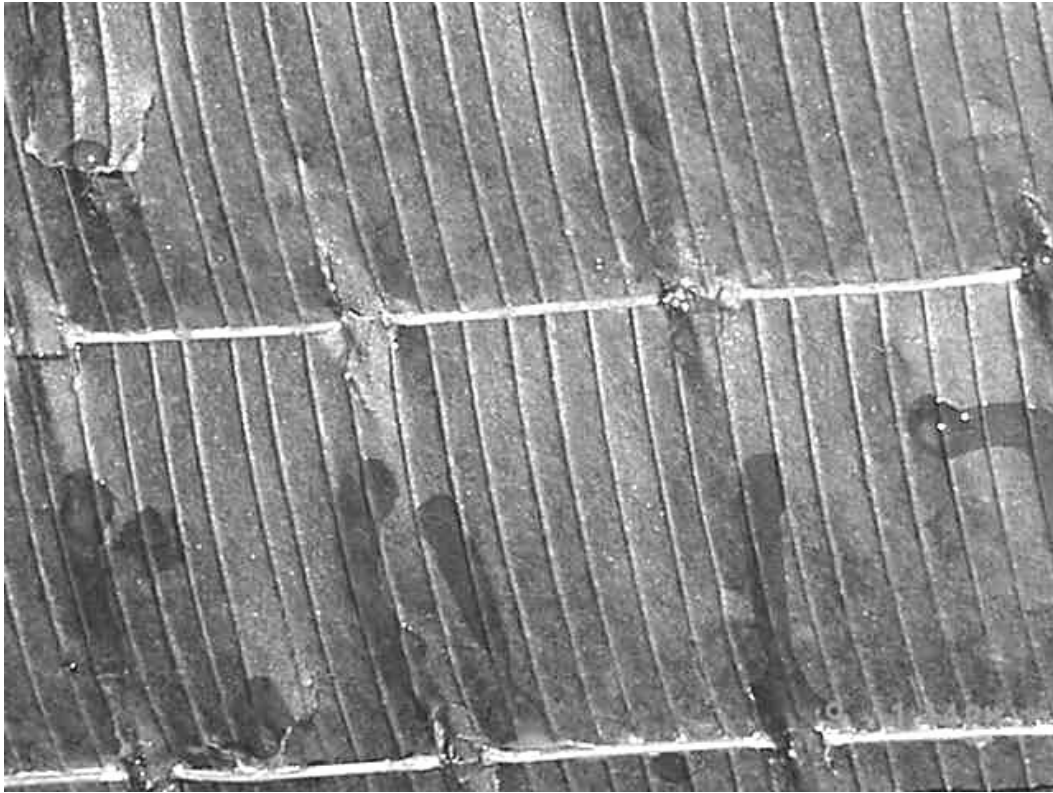
Picture 7

Water Accumulation on Cardboard Ceiling Backing Material

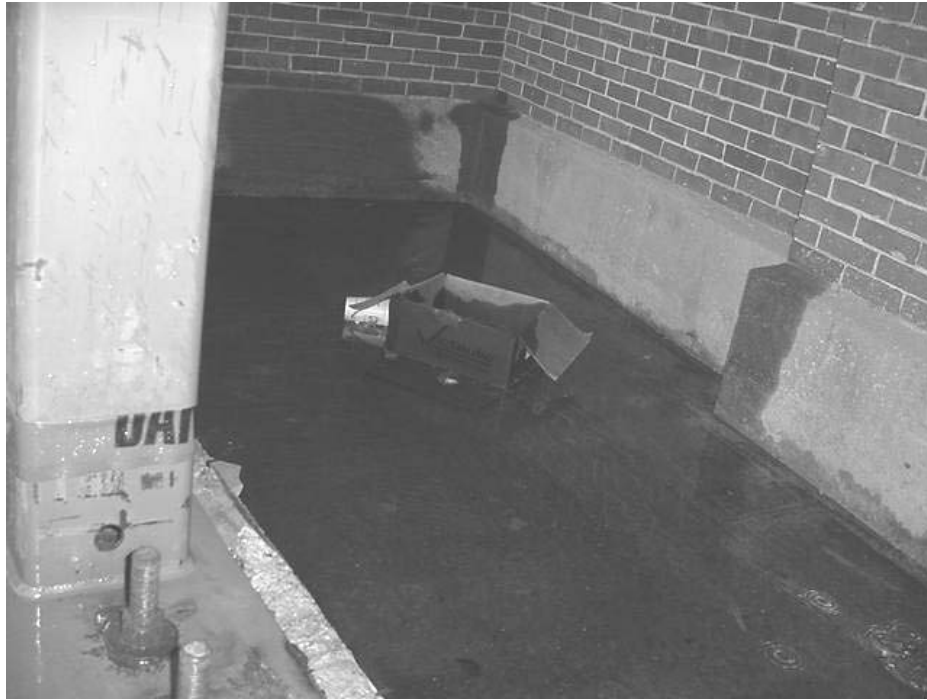
Picture 8

- In an area formed by a handicapped access ramp for the auditorium area, an accumulation of 3-6 inches of rainwater was noted. This water was leaking into the auditorium through the common wall (see Pictures 8 & 9). Moistened wall plaster and accumulated debris were also noted beneath the stage.
- Some ductwork interiors are lined with fiberglass insulation. Both installed and stored ductwork were found to have moistened insulation.
- Insulation of the boilers was found to be moistened.
- The edges of the gymnasium hardwood floor near locker room doorways were found to be moistened (see Picture 10).

Handicapped Ramp Area Holding 3-6 Inches of Water, Note This Water Was Leaking Through The Wall into the Auditorium

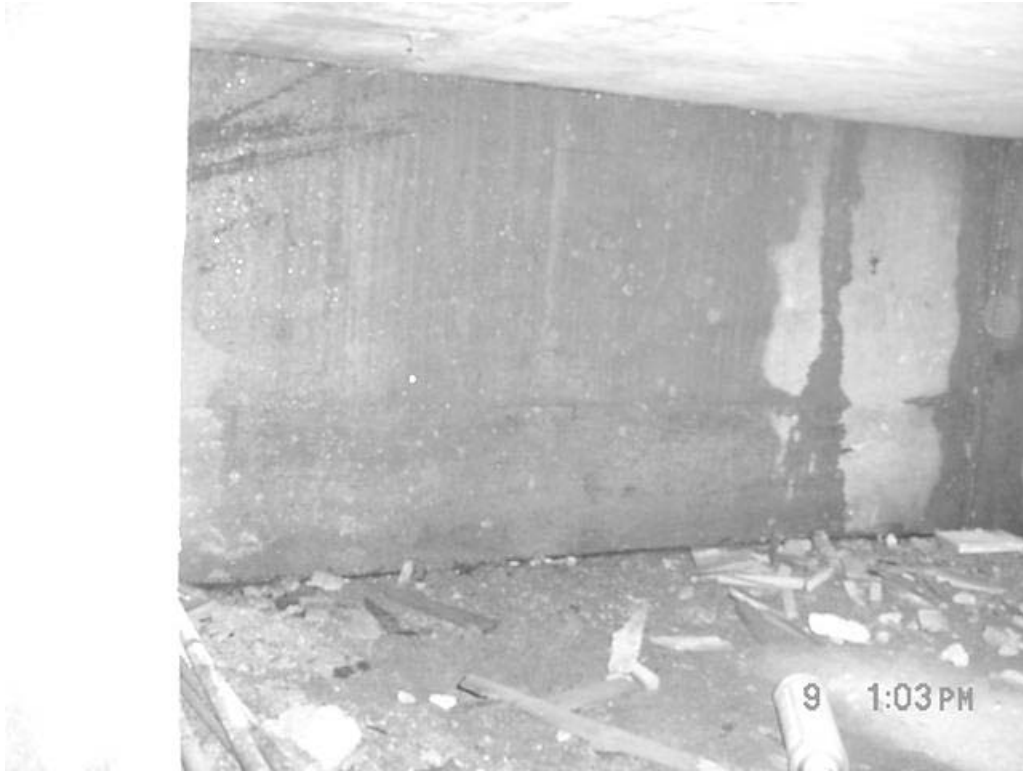
Picture 9

**Water Seepage (Dark Staining) Beneath the Stage in the Auditorium,
Opposite The Handicapped Ramp in Picture 8**

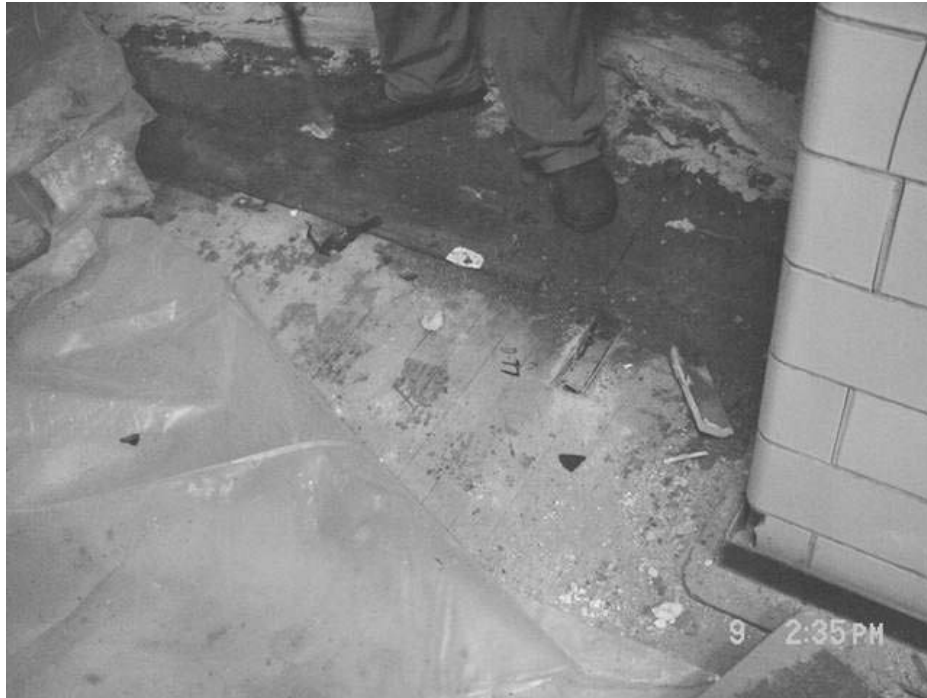
Picture 10

Gymnasium Hardwood Floor at Doorway Was Found To Be Heavily Moistened

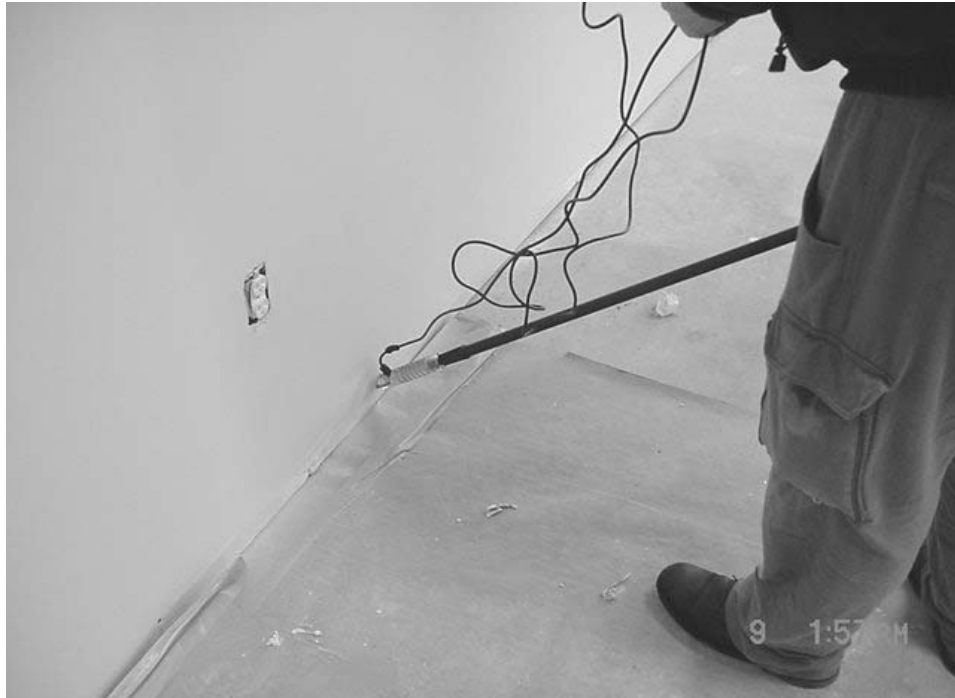
Picture 11

Moisture Sampling of GW

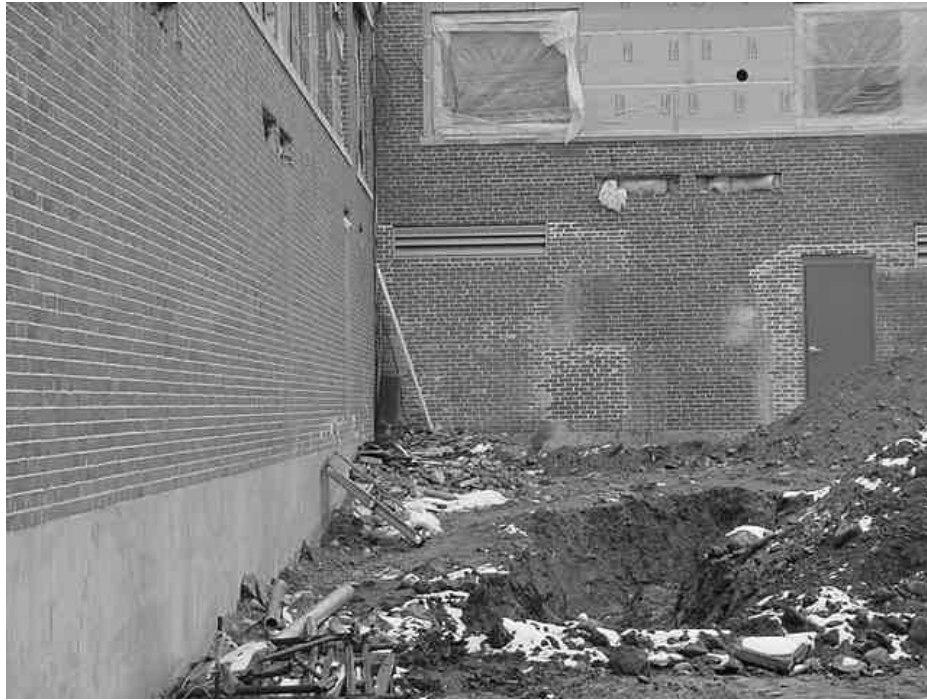
Picture 12

Exterior Curtain Walls of the Unfinished Sections Are Brick

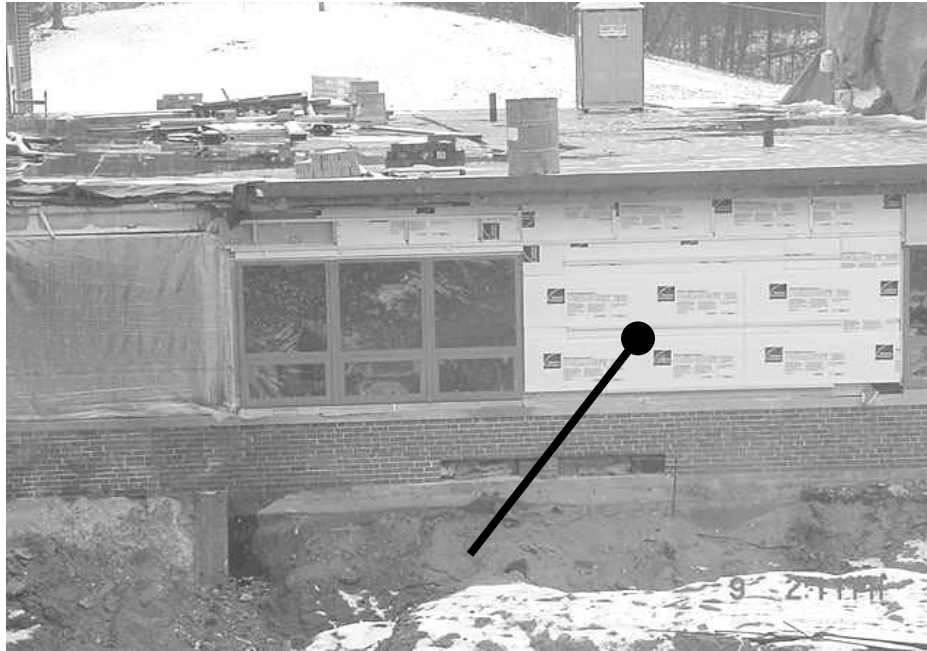
Picture 13

Styrofoam-Like Material Adhered to GW

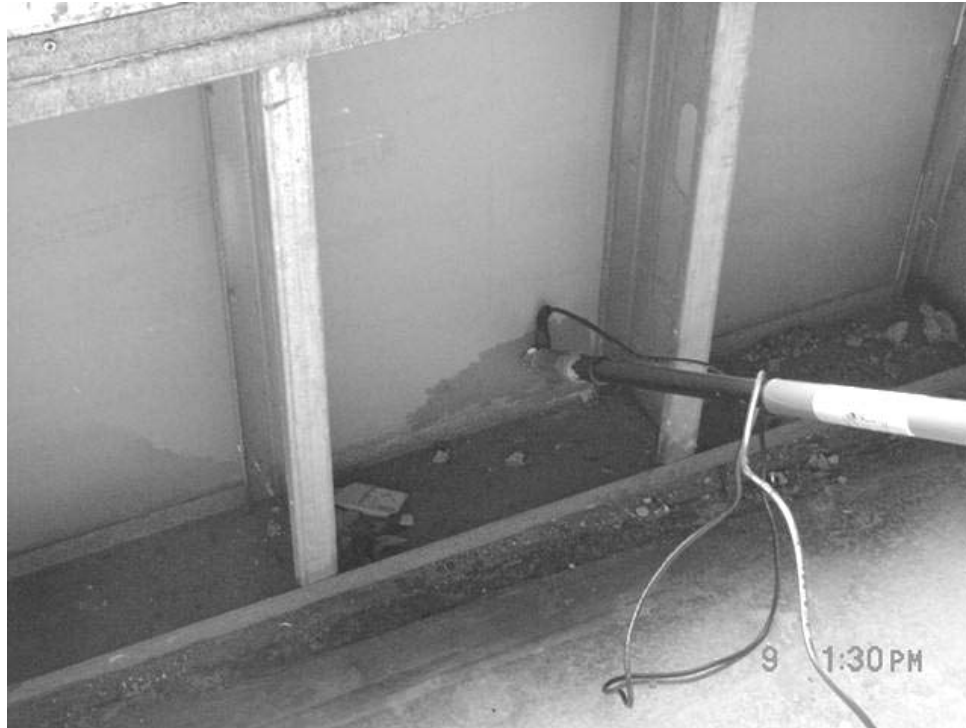
Picture 14

Interior Surface of GW Adhered to GW Styrofoam-Like Material

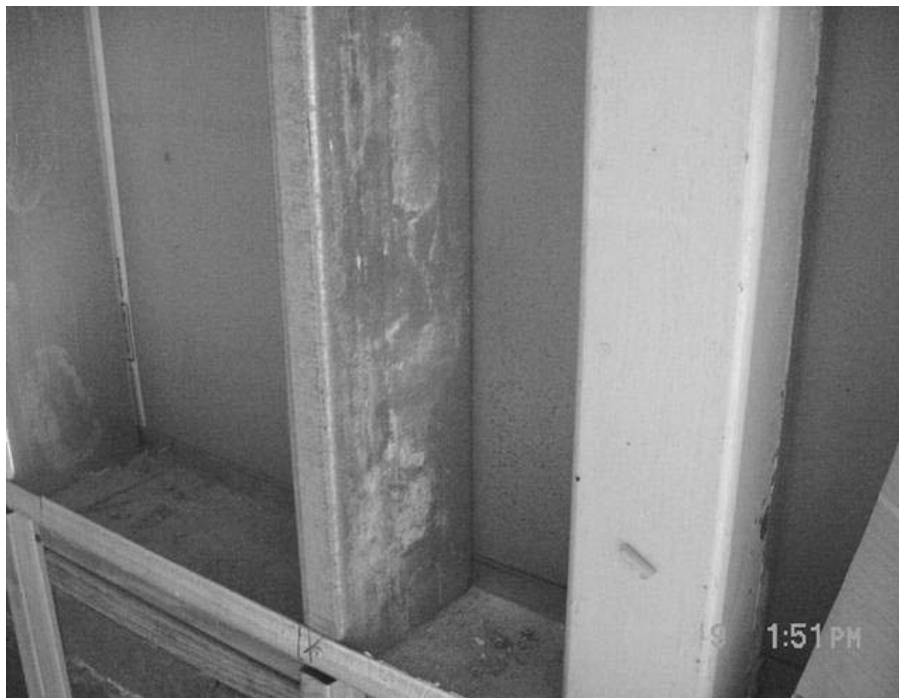
Picture 15

GW is used in a number of applications. The material was used extensively in building areas that later experienced heavy water accumulation/penetration. Moisture measurements were taken in GW (see Picture 11) and wall plaster in areas with obvious water damage, as well as in areas that appeared not to be water damaged. In many areas under renovation, GW had measurable moisture levels, ranging from 0.1 percent in the dry, “finished” wing to 99% saturation in the “unfinished” wing. The exterior curtain walls of the unfinished sections are brick (see Picture 12). Behind the brick curtain wall is a Styrofoam-like material that is adhered to GW (see Picture 13). Moisture samples were taken in numerous areas where the Styrofoam-like material is adhered (see Picture 14). In numerous areas, this GW had moisture readings indicating excessive moisture exposure. Similar moisture concentrations were found in GW making up interior dividing walls. Bare GW and painted cinderblock walls within many areas had what appeared to be visible mold growth (see Pictures 15-18). This mold growth indicates

that GW was saturated with water, resulting in the colonization of mold. In addition, a stack of GW to be installed had elevated moisture content (see Picture 19).

Water Damage/Viable Mold Growth on GW

4. Replace all GW that show visible microbial growth.
5. Consult a building engineer to determine whether the following building components are salvageable with regard to water/damage, mold growth and/or structural integrity:

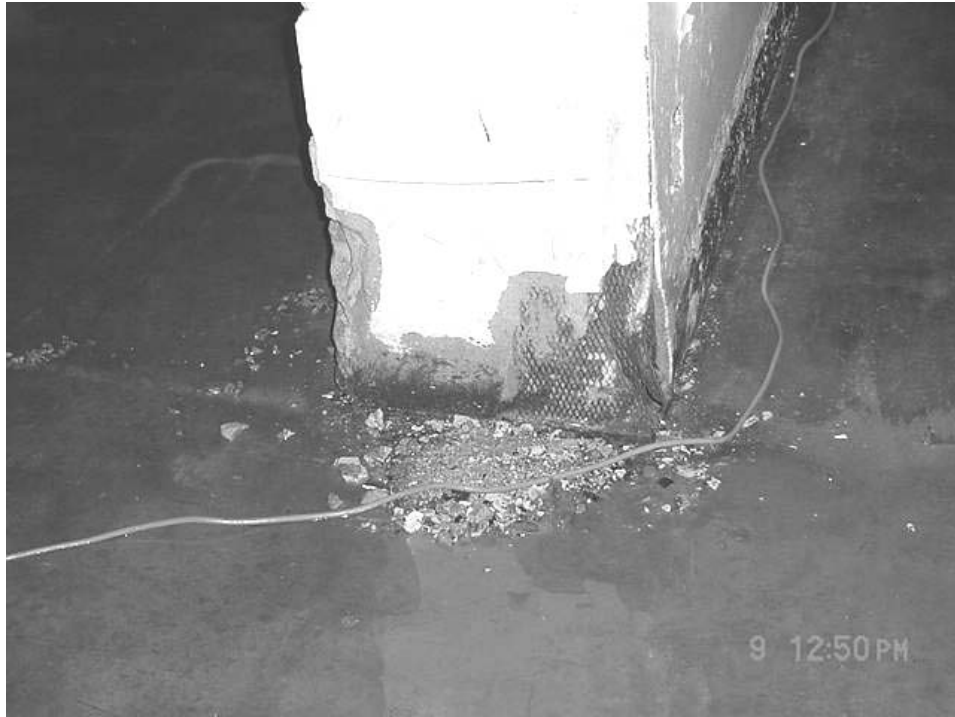
Picture 16

Water Damage/Mold Growth on Wall Plaster, Note Exposed Wire Mesh

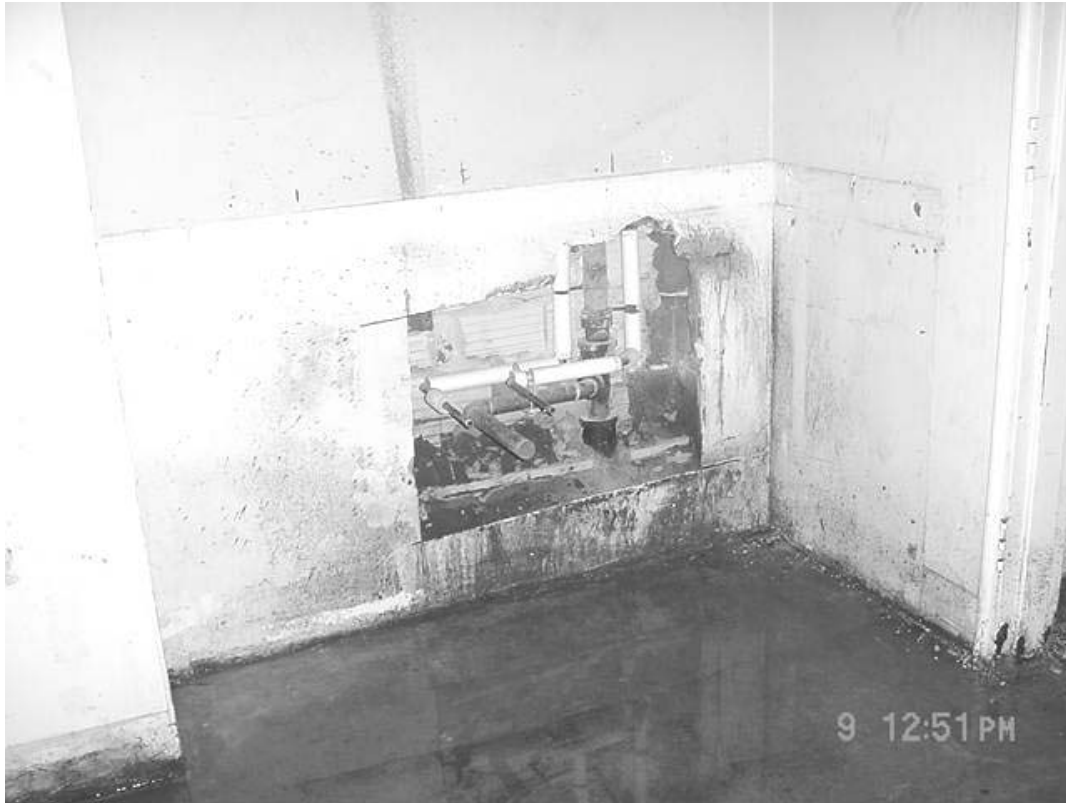
Picture 17

Water Damage/Mold Growth on Wall and Standing Water on Floor

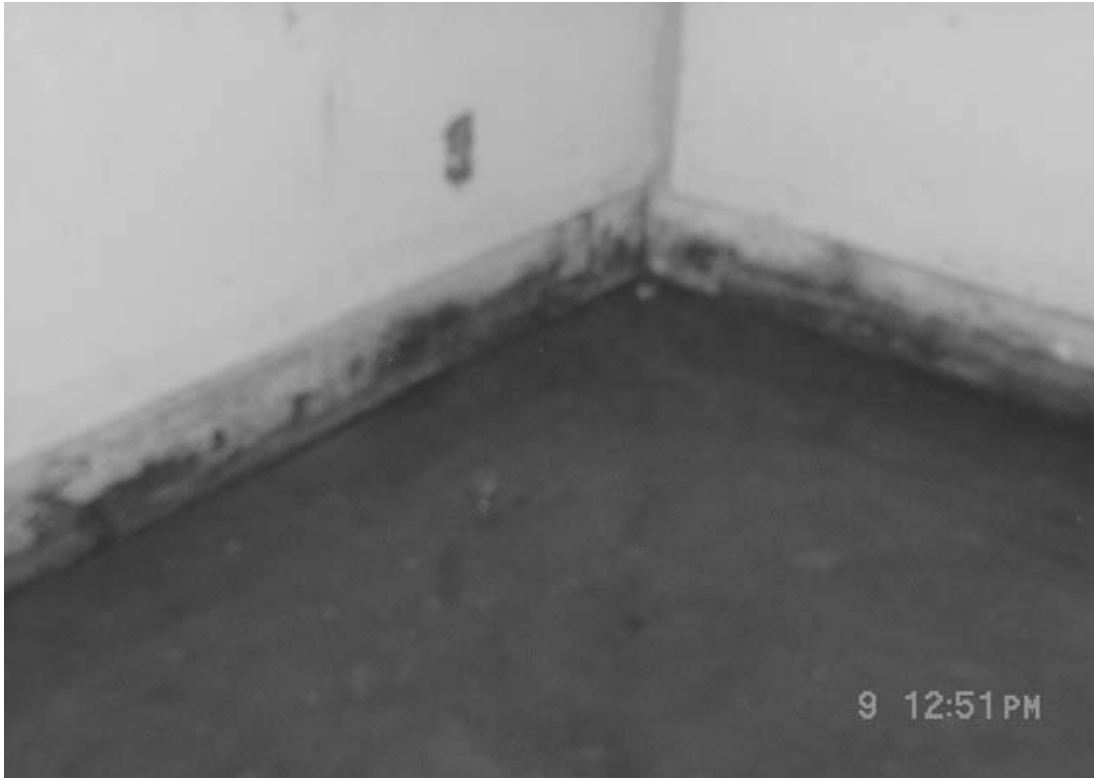
Picture 18

Standing Water and Black Mold Growth along Base of Wall

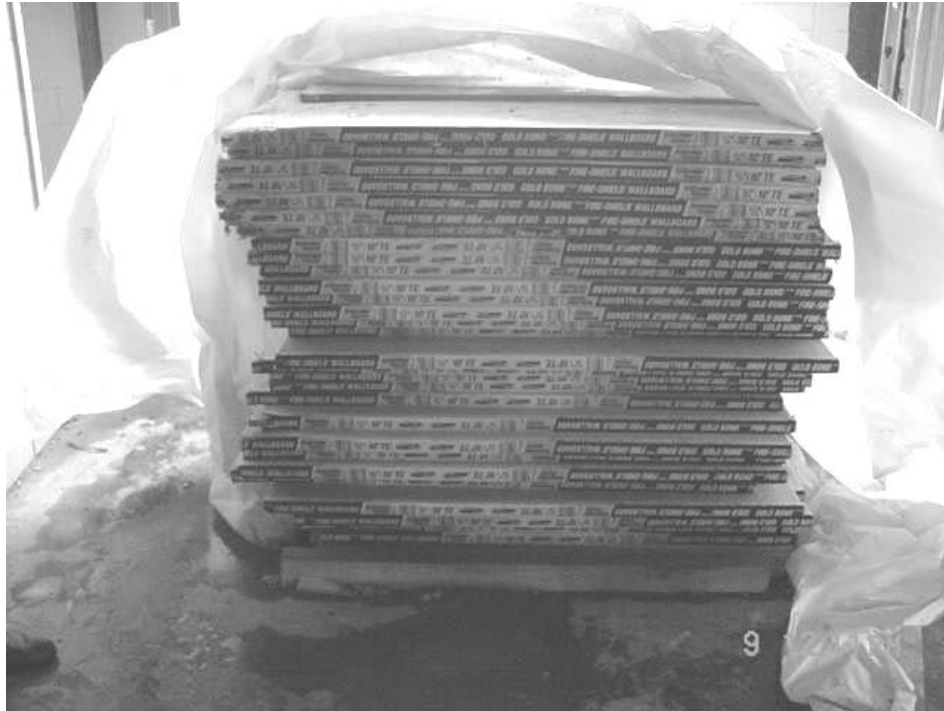
Picture 19

Stack of Stored GW in Unfinished Wing

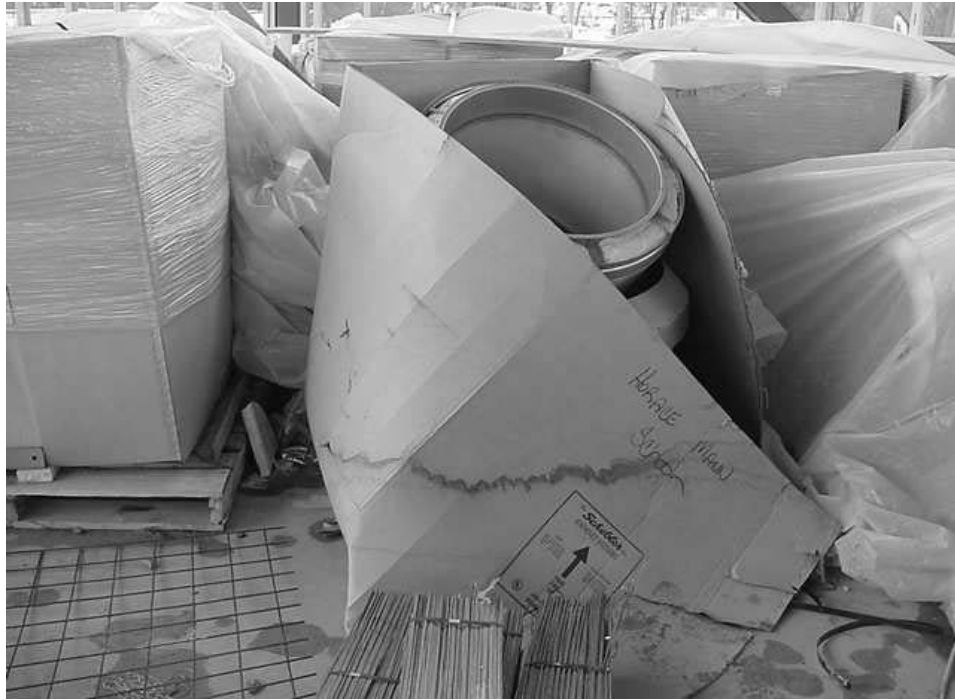
Picture 20

Ductwork to Be Installed Stored Outdoors On Slab, Note Water Damage to Box

- 5.6. the boilers.
6. Clean dust off all ductwork that remains to be installed and store it in a manner that prevents contamination with renovation-generated dust.

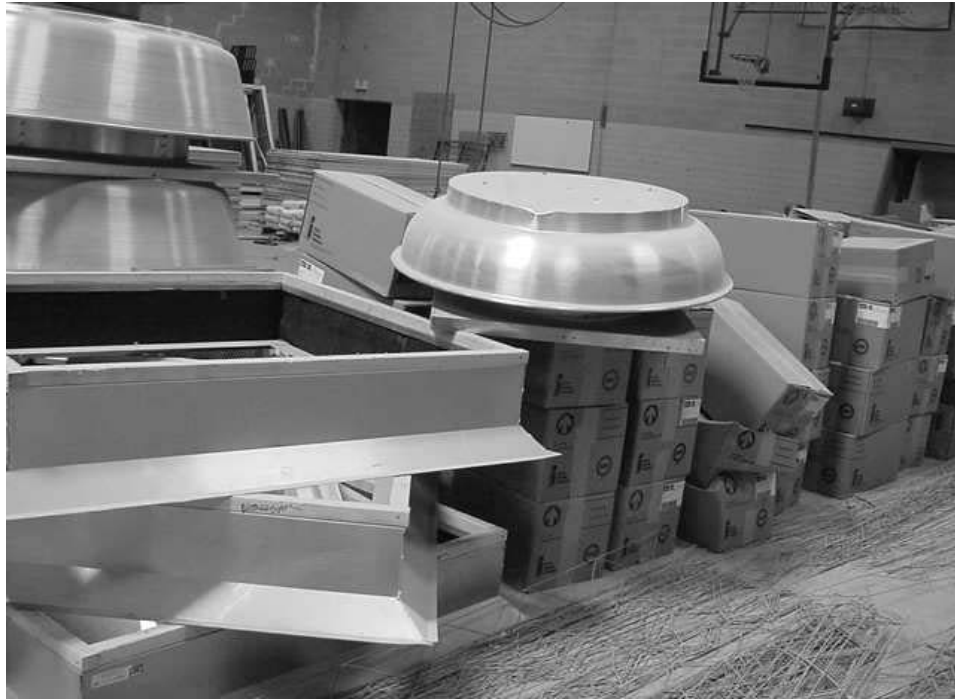
Picture 21

Ductwork was partially installed in the building. Openings to ductwork were noted in classrooms through interior walls above hallway doors. Some of the duct openings were not sealed to prevent contamination by renovation-generated dust. Ductwork to be installed was found stored on the floors of the gymnasium and outdoors (see Pictures 20-22). These ducts were heavily coated with dust. It is good practice to isolate newly installed ductwork to avoid dust contamination of these materials (SMACNA, 2000). Since it appears that these ducts were open in a number of areas throughout the building, there are opportunities for both installed and/or stored ductwork to be contaminated by renovation pollutants. Therefore, the design of the ductwork system must be assessed to determine how it may be impacted by renovation activities.

Ductwork to Be Installed Was Found Stored On the Floors of the Gymnasium

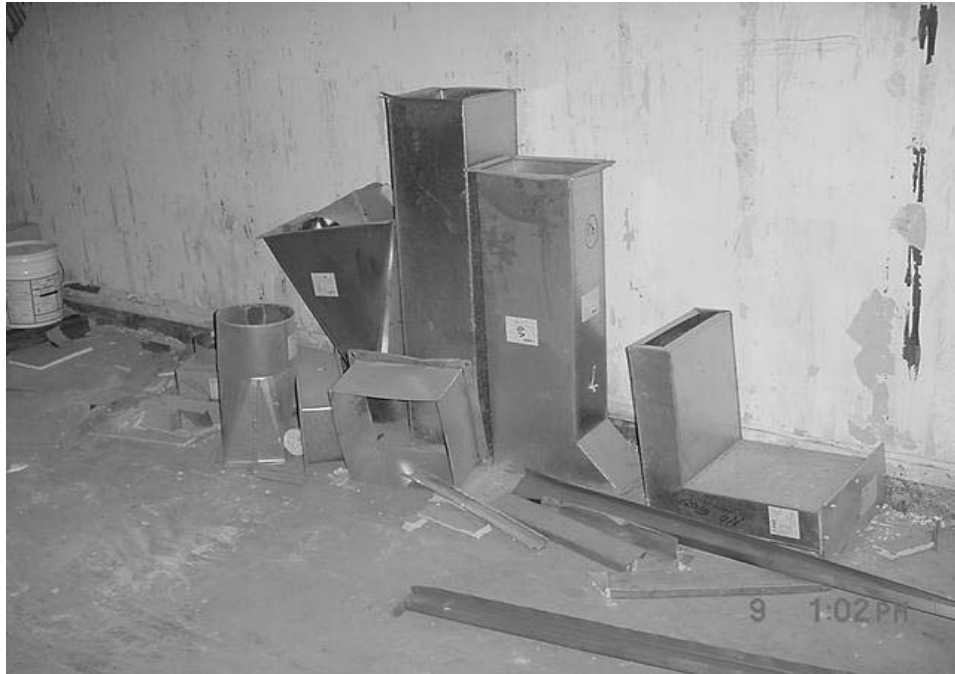
Picture 22

Ductwork Stored On the Floor of the Auditorium
